REPORT NO. 176

PROJECT CGTD J16/2-3-4

PHOTOELECTRIC ALARM DEVICE
FOR ROTATING OPTICAL SYSTEMS

**FIELD TESTING AND DEVELOPMENT UNIT
U. S. COAST GUARD YARD
Curtis Bay, Baltimore 26, Maryland**

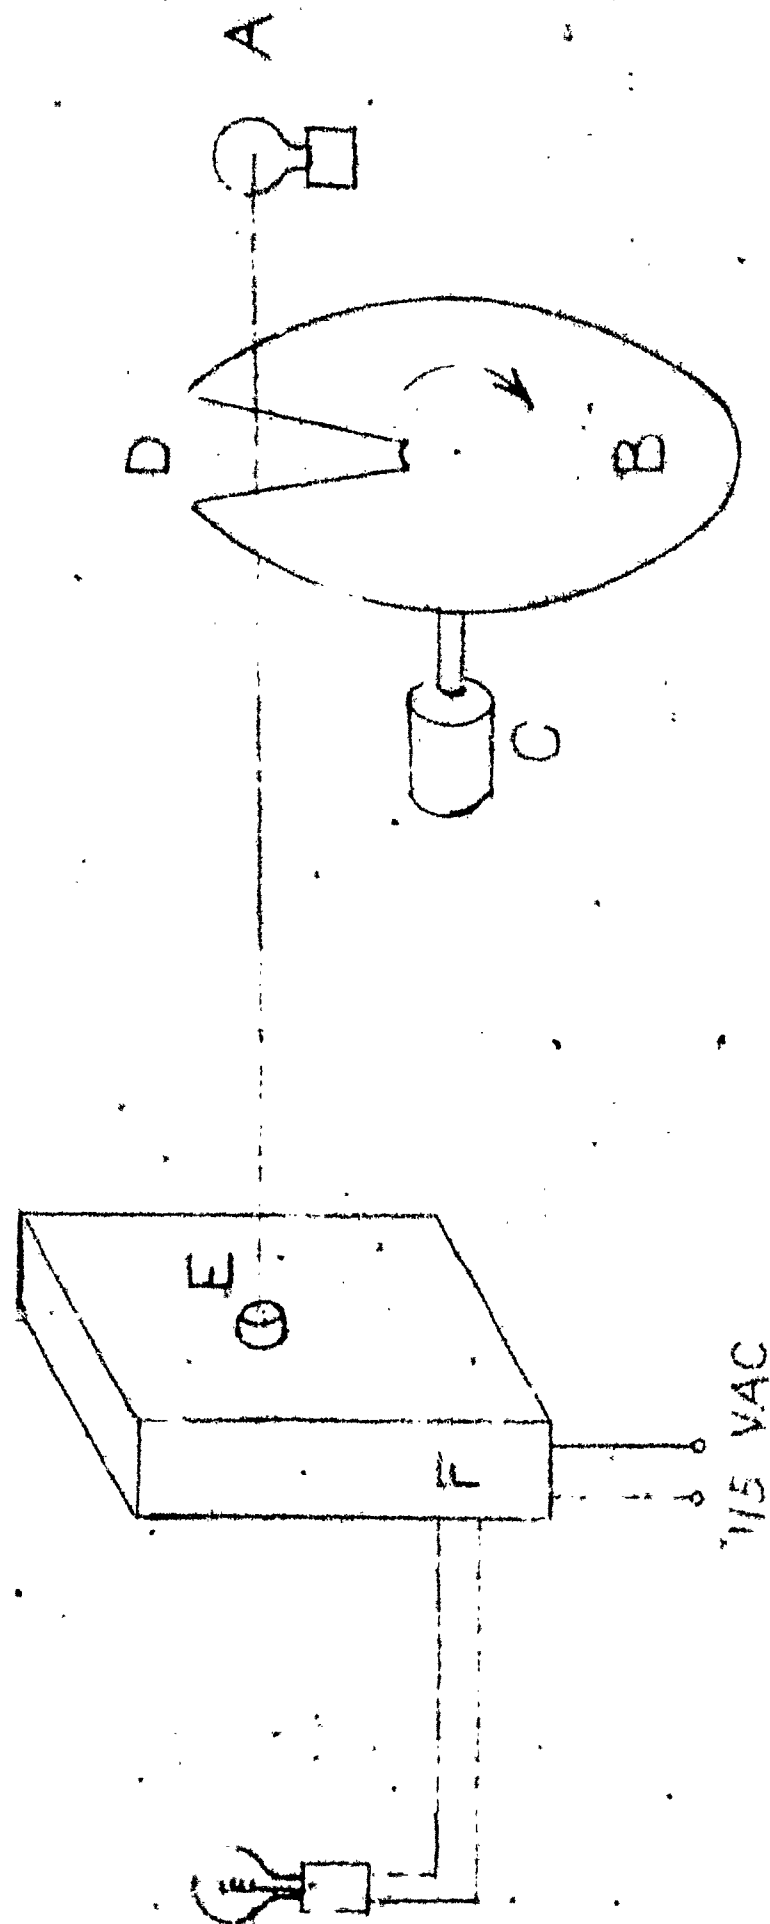
F.T.D.U. SKETCH NO. 174

6.1 Experimental set-up. The set-up for the first phase of the tests is shown by the schematic of Figure 2 (Page 3). Light from the steady-burning lamp, A, periodically interrupted by the rotating disc, B, with aperture, D, was incident upon the window, E, of the alarm device F. A variable speed motor, C, driving the disc, provided a means of varying the flash period. The load side of the relay within the device was connected to a yellow incandescent lamp, such that, for a given sensitivity setting on the alarm unit, a sufficient decrease in the illuminance of the phototube and/or decrease in speed of rotation of the disc caused this lamp to be lighted.

FIGURE 2. TEST SET-UP FOR PHOTOELECTRIC ALARM CALIBRATION

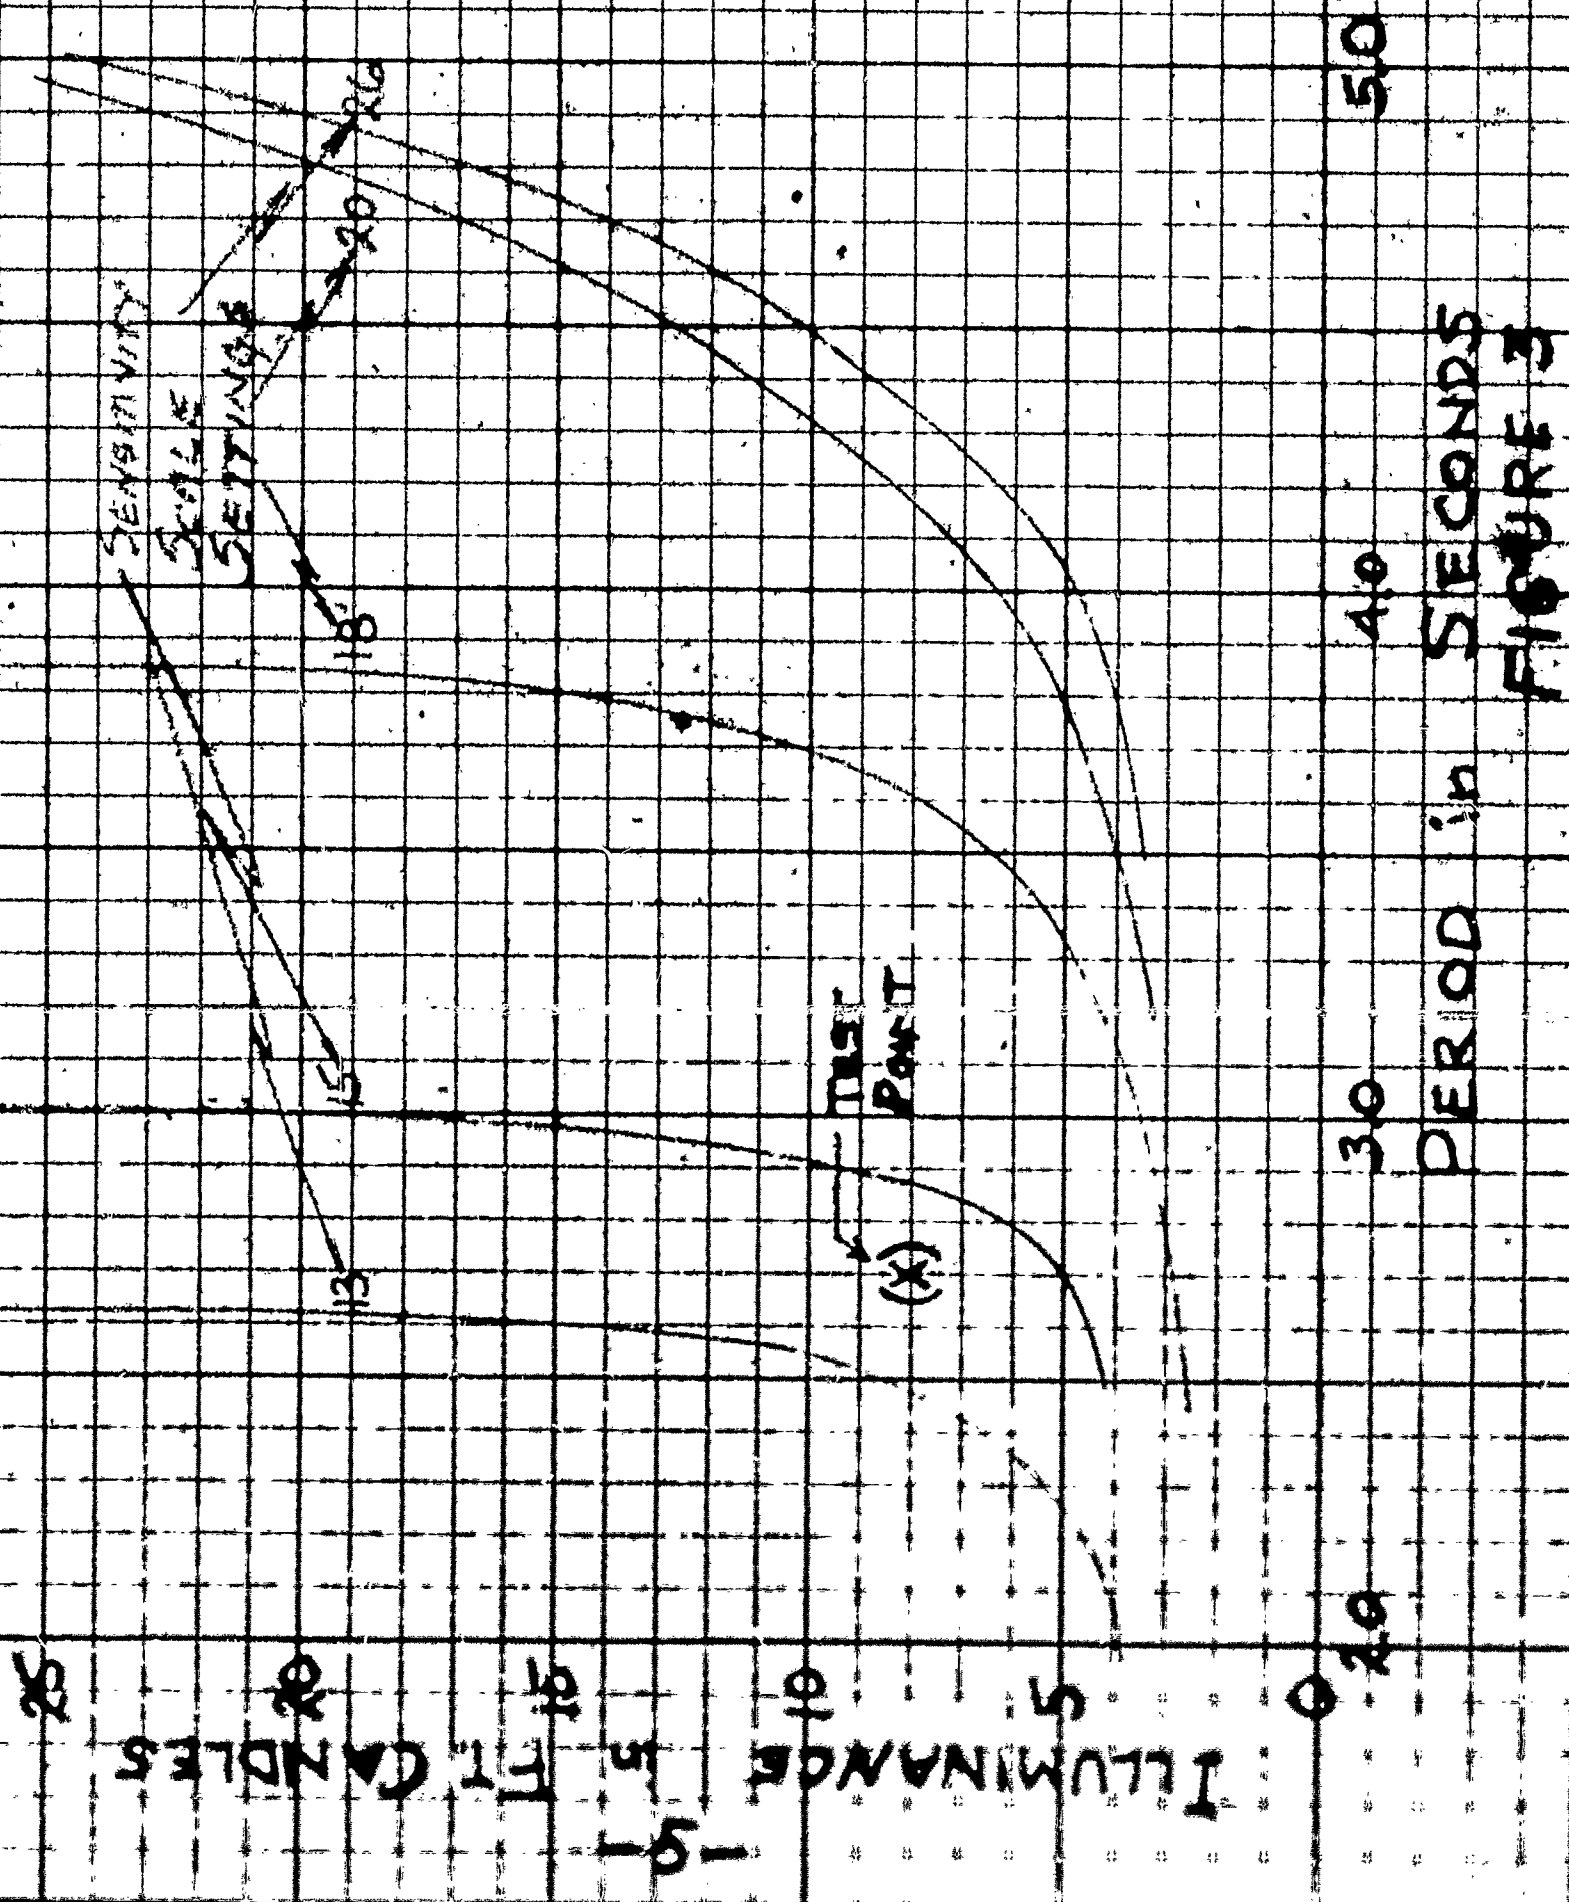
FTDU SK. NO. 170
JAC 1 AUG 1956

7.1 Calibration Curves. The calibration curves for the alarm device are shown in Figure 3 (Page 5). The parameters on the curves are the arbitrary reference numbers on the scale which FTDU added to the sensitivity adjustment screw.

FIGURE 3:
CALIBRATION OF
SENSITIVITY CONTROL
MODEL 20 DAR

8.1 The calibration curves of Figure 3 indicate, in general, the range of illuminance and flash periods over which the tested alarm device operates satisfactorily in a new condition. It should be noted, however, that these curves apply to a specific light to dark ratio, which was not recorded when the data were taken.
